ROD PUMPING FAILURE ANALYSIS

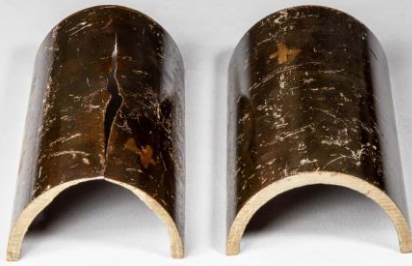
Problem: Tubing splits

Cause: Rod wear against tubing

- (1) Tubing rotation
- (2) Polyethylene lined tubing
- (3) Rod guides
- (4) Slow SPM
- (5) Sinker bars (if wear near bottom)
- (6) Continuous rods

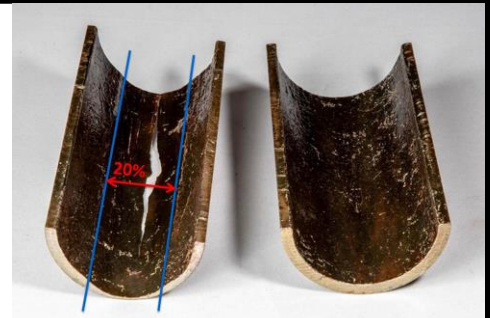
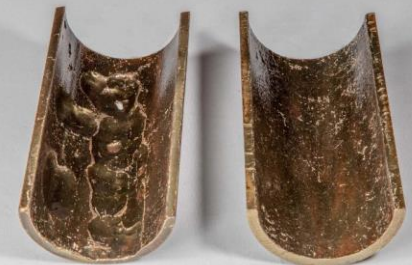
Problem: Corrosion hole from wear

Cause: Corrosion inhibitor worn off by rod string (rod boxes, guides or body). Corrosion occurs over 20% circumference with rest of tubing in good condition.

- (1) Manual tubing rotation
- (2) Polyethylene lined tubing remedy for rod corrosion due to wear:
 - * rod rotators
 - * spray metal alloy boxes

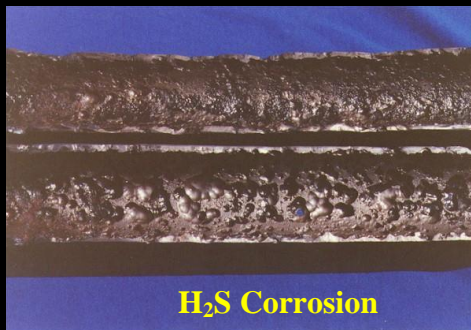
H₂S Corrosion

Problem: Corrosion pitting around circumference of tubing or rods

Cause: Corrosion due to poor inhibitor film. Uniform pitting around circumference suggest wiping inhibitor off isn't the issue (unless automatic rotator used).

- (1) Change chemical program (type, frequency or circulation time)
- (2) Minimize corrosion causing elements (oxygen entry, bacteria, etc.)
- (3) Fiberglass tubing/rods
- (4) Manual tubing rotation with proper chemical program (batch after rotation)

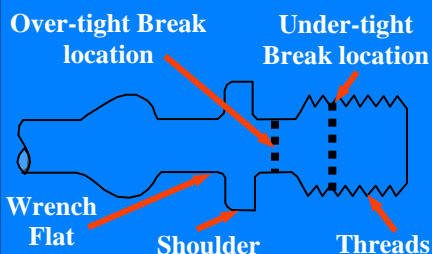
Under-tight pin break

Problem: Pin breaks due to make-up

Cause: Over or under-tightening connections

- (1) Proper make-up
