**OMEGA
TECHNOLOGIES
INC.**

TUBING SAVER ROTATOR (TSR, Patented)

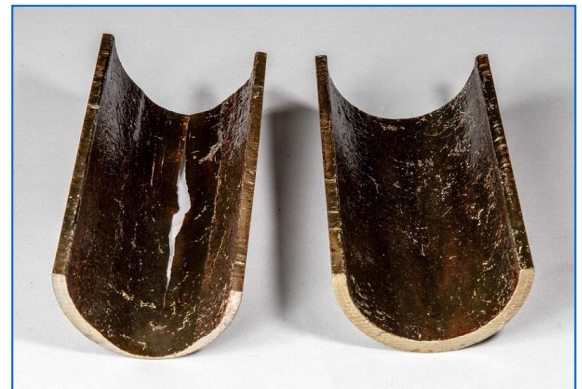
- A "tubing split" is often accomplished by the tubing being worn thin and smooth on one side (usually a straight path being 20% of the circumferential area and the length of the pump stroke) until the pressure in the tubing blows a hole in the tubing. The picture on the right shows a thin smooth section on the right half of the tubing with a split at the top {a rod box would fit nicely in the worn area with 80% of the area not worn at all}. The TSR spreads this wear over the entire circumference to extend run times by potentially 500%.

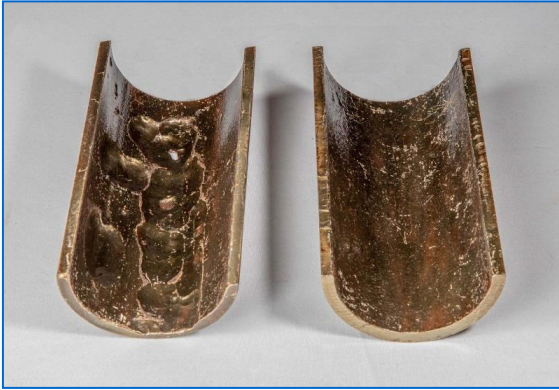
The Figure on the left shows severe pitting along the width of a rod box (tubing was wetted for enhancement), which also was thinner above and along the pitting area (indicating wear wiping off inhibitor since the rest of tubing has very minor corrosion). The Figure below shows tubing with external wear with pitting along 20% of the tubing’s circumference (I.D. is the same but O.D. is worn along a straight line indicating tubing wear against casing (unanchored tubing). This “Corrosion Due to Wear” mechanism will **not normally** be solved by (a) installing rod guides and/or (b) redesigning the chemical program (if 80% of area is unpitted, then the problem is not normally due to chemical type or treatment method). Intermittent rotation with a TSR spreads out the corrosion area to reduce the frequency of

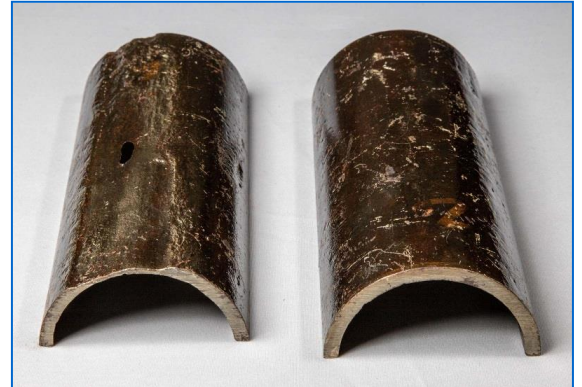
- A “rod box failure due to wear” will often have one side of the box worn down until the box fails. Rod guides, which are continuously replaced, may temporarily correct this at the expense of increasing rod stresses and the circumferential area for corrosion (certain rod guides may wipe off inhibitor from a larger area). One solution is to install Spray Metal Alloy boxes, which are less corrosive and “smoother” (reduces friction and wear) and are very hard to wear down. With less friction and tubing rotation, the service life may be substantially improved.
- A “rod body failure due to wear” will often have one side of the rod body worn down until the body fails due to tension, particularly in deviated wells. This is often temporarily corrected or delayed by Rod Guides. This is not as big a problem in relatively straight wells because most wear occurs at the rod box site.
